**PUBLIC ADVOCATES OFFICE**  
**CALIFORNIA PUBLIC UTILITIES COMMISSION**

**REPORT AND RECOMMENDATIONS**  
**ON REGION I - CAPITAL PROJECT FORECAST:**  
**(ARDEN CORDOVA, BAY POINT,**  
**CLEARLAKE, LOS OSOS,**  
**SANTA MARIA & SIMI VALLEY)**

Los Angeles, California  
February 27, 2024

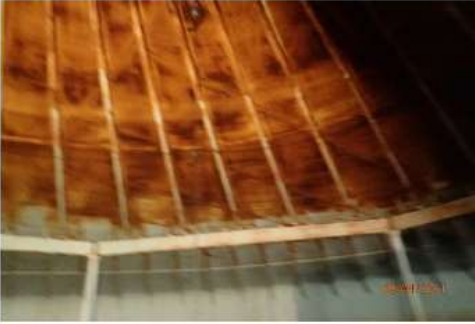
3 GSWC also has a history of mismanaging this reservoir. GSWC has known about  
 4 the corrosion since at least 2015,<sup>10</sup> but failed to address the issue. In a 2021 inspection  
 5 report, the corrosion in the interior roof had increased from the condition identified in  
 6 2015 inspection report. The 2021 report indicated that "..., [since] the last inspection the  
 7 corrosion has increased about 5% totaling around 15 % of the trusses being covered in  
 8 corrosion."<sup>11</sup> The report also showed pictures of corrosion covering 20% in the interior  
 9 roof as shown in Figure 1.1.<sup>12</sup>

Vent Penetration	Fair-poor				
Roof Hatch	Fair-poor				
Conclusion/Discrepancies:	Coating on the edges of the trusses has failed and corrosion has damaged the edges of the trusses. Corrosion also noted along the seams

1 As a result of GSWC’s failure to maintain the reservoirs properly, both the 2021  
2 and the 2022 inspection reports identified that the reservoir is experiencing substantial  
3 corrosion and damage to its interior surface. This includes corrosion on the edges of the  
4 trusses, corrosion related to structural damage, and loss of truss integrity, all of which is  
5 also depicted in the photos within the reports. This corrosion is significantly worse than  
6 was observed in the 2015 inspection report.

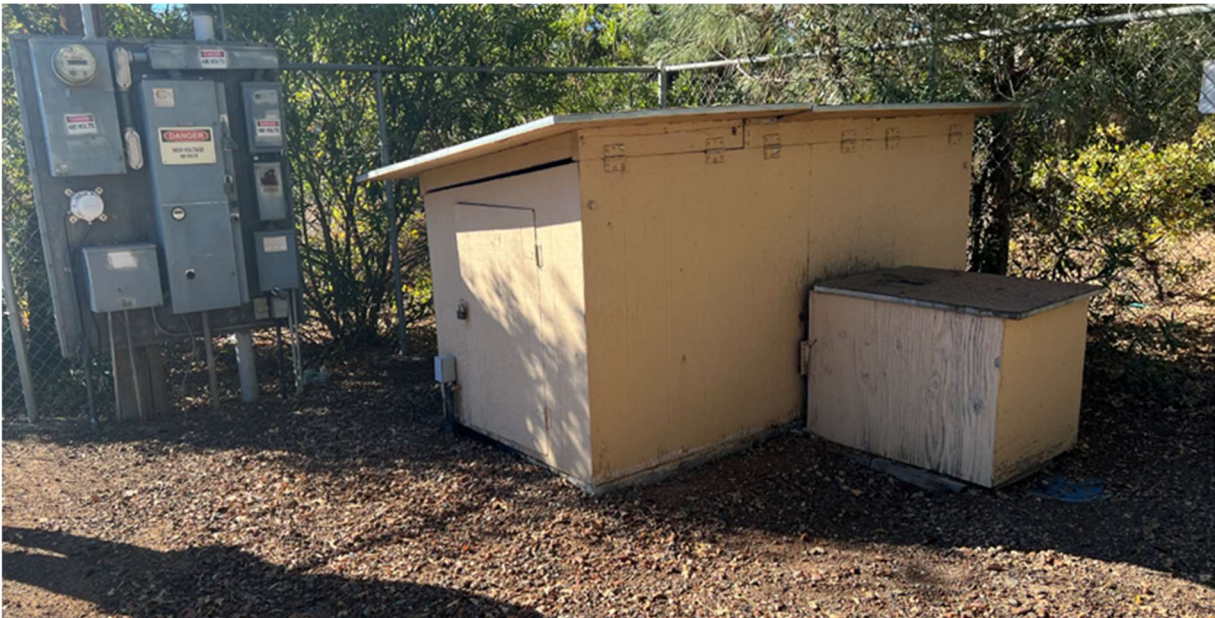
**Figure 3-1. Cal Advocates field trip to Manchester plant site on October 30, 2023**

5  
6 During the site visit, Cal Advocates did not observe any apparent issues with the  
7 wooden pump house.<sup>48</sup> Furthermore, it should be readily evident from the picture above  
8 that \$260,400 to replace the wooden pump house appears incredibly excessive. Records  
9 show that GSWC is able to operate the booster pump and perform necessary  
10 maintenance. GSWC’s pump test reports show that from 2019 to 2023, its operator  
11 accessed the pump 5 times in the last five years for the annual routine pump tests.<sup>49</sup>

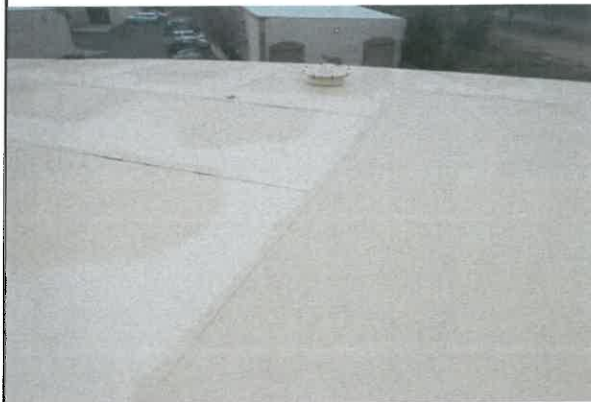
<b>Conclusion/Discrepancies:</b>		Overall good typical nicks and scratches

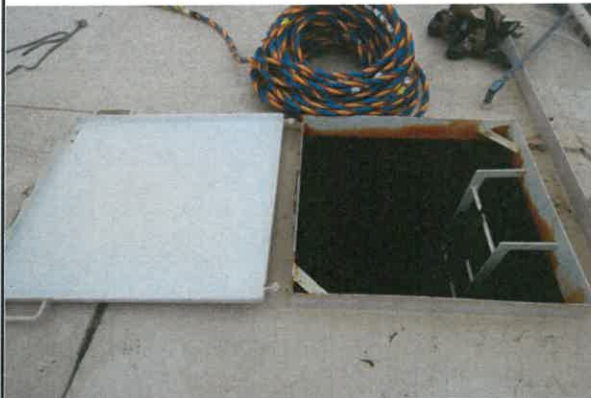
## ACCESS HATCH

Satisfactory		Y	<input checked="" type="checkbox"/>	N	<input type="checkbox"/>		
<b>Coating</b>		Corrosion	10%	Y	<input checked="" type="checkbox"/>	N	<input type="checkbox"/>
Proper Design			Y	<input checked="" type="checkbox"/>	N	<input type="checkbox"/>	
Locked			Y	<input checked="" type="checkbox"/>	N	<input type="checkbox"/>	
Gasket			Y	<input type="checkbox"/>	N	<input checked="" type="checkbox"/>	
Hinge		Good					
Hatch Size		3 FT	X	3 FT			
<b>Conclusion/Discrepancies</b>		Corrosion on the interior of the riser. Lid and hardware in good condition. No gasket present

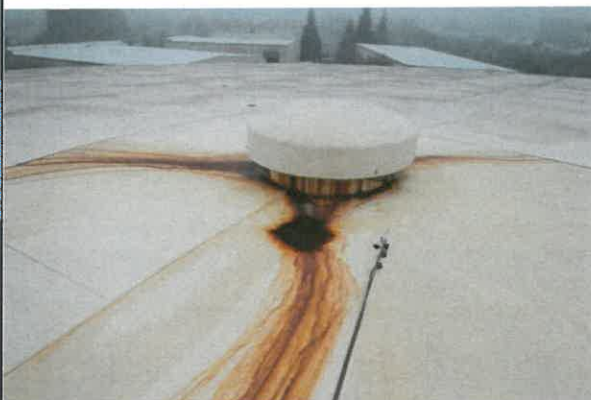
## VENTS

Satisfactory		Y	<input type="checkbox"/>	N	<input checked="" type="checkbox"/>		
<b>Coating</b>		Corrosion	10%	Y	<input checked="" type="checkbox"/>	N	<input type="checkbox"/>
Proper Design			Y	<input checked="" type="checkbox"/>	N	<input type="checkbox"/>	
Screens			Y	<input checked="" type="checkbox"/>	N	<input type="checkbox"/>	
Sealed Edges & Seams			Y	<input type="checkbox"/>	N	<input checked="" type="checkbox"/>	
Cap/Cover			Y	<input checked="" type="checkbox"/>	N	<input type="checkbox"/>	
<b>Conclusion/Discrepancies</b>		Securing bands holding the screen are both broken and need replaced. Screen is corroded but holding up well

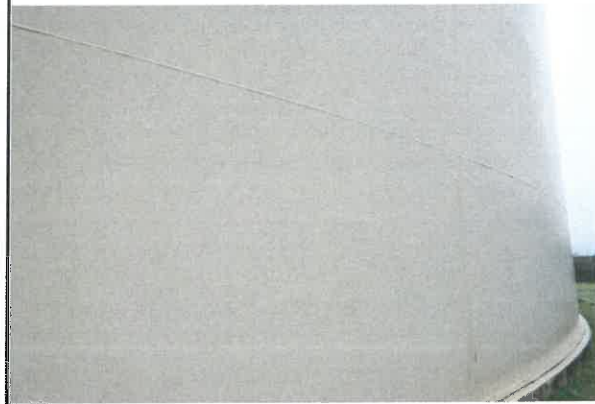
## EXTERIOR SHELL

Conclusion/Discrepancies Overall good. Coating is oxidized but adhesion is excellent typical nicks and scratches present

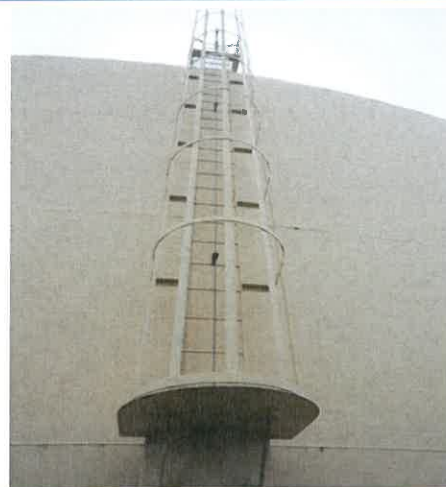
## EXTERIOR LADDER

Conclusion/Discrepancies Ladder cage and supports are all in good condition

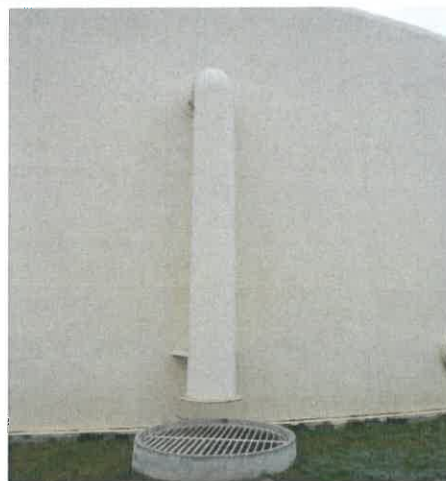
## OVERFLOW STRUCTURE

Conclusion/Discrepancies Pipe and screen are in good condition

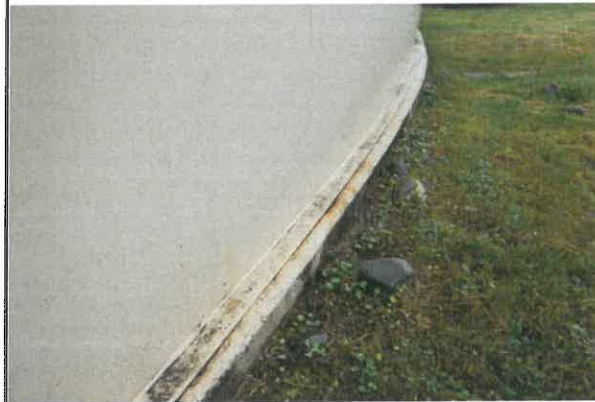
## FOUNDATION

<b>Concrete Slab/Ring</b>				
Satisfactory	Y	<input checked="" type="checkbox"/>	N	<input type="checkbox"/>
Cracking	Y	<input type="checkbox"/>	N	<input checked="" type="checkbox"/>
Spalling	Y	<input type="checkbox"/>	N	<input checked="" type="checkbox"/>
Exposed Aggregate	Y	<input type="checkbox"/>	N	<input checked="" type="checkbox"/>
Erosion Undermining	Y	<input type="checkbox"/>	N	<input checked="" type="checkbox"/>
<b>Seismic Restraints</b>				
	None			
Corrosion	Y	<input type="checkbox"/>	N	<input type="checkbox"/>
Tight	Y	<input type="checkbox"/>	N	<input type="checkbox"/>
<b>Conclusion/Discrepancies</b>				
Support ring is in good condition. No undermining or erosion noted

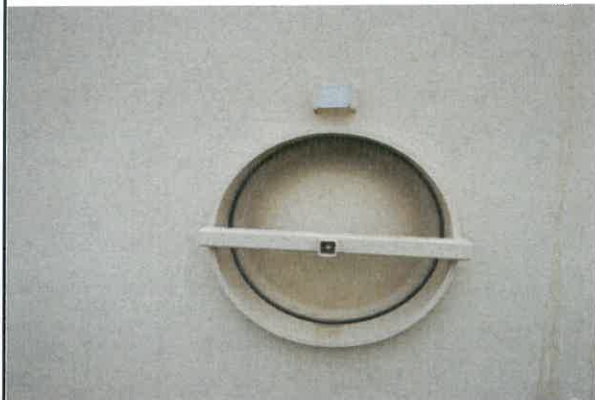
## MANWAY ENTRIES

<b>Coating</b>				
Satisfactory	Y	<input checked="" type="checkbox"/>	N	<input type="checkbox"/>
Oxidized	Y	<input checked="" type="checkbox"/>	N	<input type="checkbox"/>
Pitting	Y	<input type="checkbox"/>	N	<input checked="" type="checkbox"/>
Delamination	Y	<input type="checkbox"/>	N	<input checked="" type="checkbox"/>
Corrosion	>2% Y	<input checked="" type="checkbox"/>	N	<input type="checkbox"/>
<b>Welds/Joints</b>				
Good				
<b>Conclusion/Discrepancies</b>				
Minor corrosion on bottom edge of extension

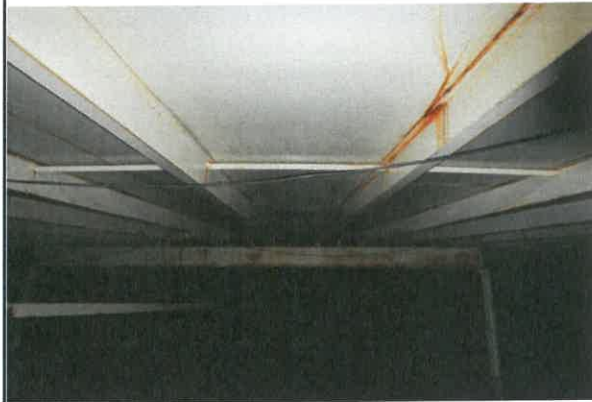
## INTERIOR ROOF

Vent Penetration	Fair-poor		
Roof Hatch	Fair-poor

**Conclusion/Discrepancies:** Coating on the edges of the trusses has failed and corrosion has damaged the edges of the trusses. Corrosion also noted along the seams

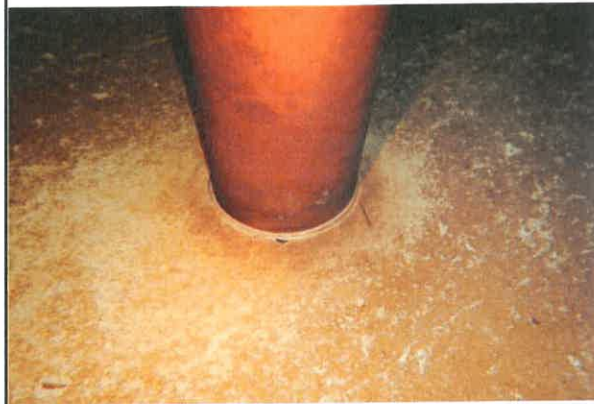
## SUPPORT COLUMNS

Coating					
Satisfactory	Fair	<input type="checkbox"/>	N	<input type="checkbox"/>	
Blistering	Y	<input type="checkbox"/>	N	X	
Cracking	Y	<input type="checkbox"/>	N	X	
Peeling	Y	<input type="checkbox"/>	N	X	
Holidays	Y	X	N		
Pitting	Y	<input type="checkbox"/>	N	X	
Corrosion	>2%	Y	X	N	<input type="checkbox"/>
Seams/Welds	Good				
Floor/Base Plates	Good				
Construction	Coated Steel				
Conclusion/Discrepancies:	Overall good minor corrosion noted on the stems with discoloration

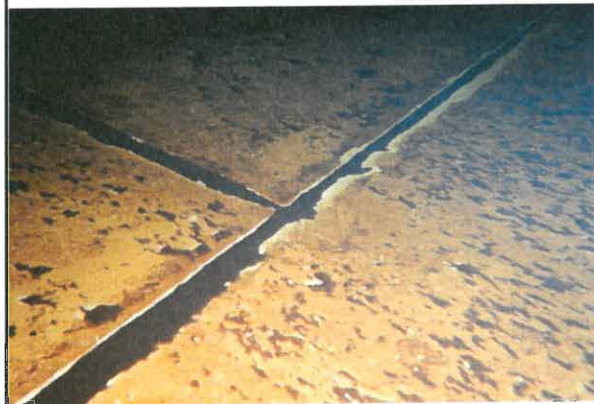
## FLOOR

Coating					
Satisfactory	Y	X	N	<input type="checkbox"/>	
Blistering	Y	<input type="checkbox"/>	N	X	
Cracking	Y	<input type="checkbox"/>	N	X	
Peeling	Y	<input type="checkbox"/>	N	X	
Holidays	Y	X	N		
Pitting	Y	<input type="checkbox"/>	N	X	
Corrosion	>2%	Y	X	N	<input type="checkbox"/>
Seams/Welds	Good				
Conclusion/Discrepancies:	Overall good minor corrosion noted on the floor plates with discoloration				
Sediment Depth	Less than a 1/16 sporadically over the floor

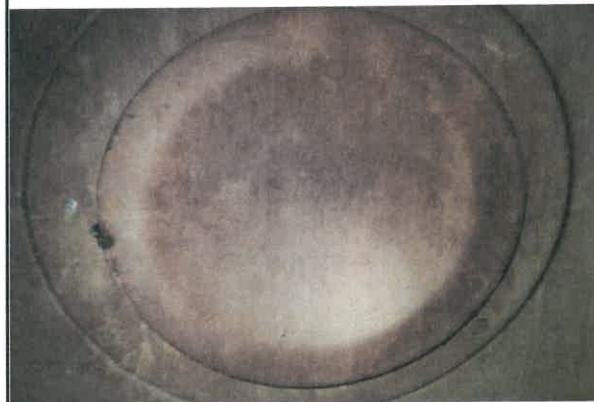
## MANWAY ENTRIES

Coating					
Satisfactory	Y	X	N	<input type="checkbox"/>	
Blistering	Y	<input type="checkbox"/>	N	X	
Cracking	Y	<input type="checkbox"/>	N	X	
Peeling	Y	<input type="checkbox"/>	N	X	
Holidays	Y	<input type="checkbox"/>	N	X	
Pitting	Y	<input type="checkbox"/>	N	X	
Corrosion	>2%	Y	X	N	<input type="checkbox"/>
Seams/Welds	Good				
Conclusion/Discrepancies:	Minor corrosion noted on the outer edges of the door. Seams and welds are in good condition

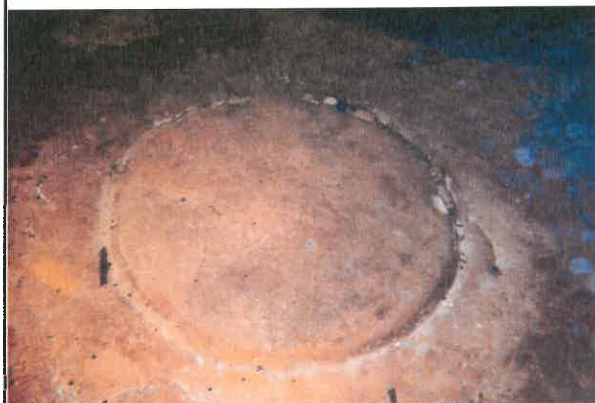
### Drain

no dedicated drain line

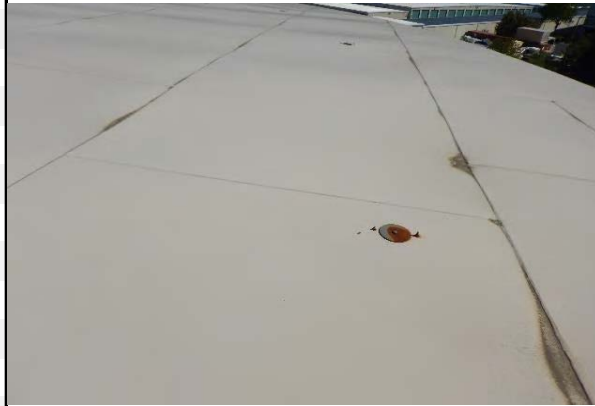
**Conclusion/Discrepancies:** Minor nicks and scratches on handrailing. Coating on the roof exhibits good adhesion being slightly oxidized. Cathodic plates do have surface rust present.

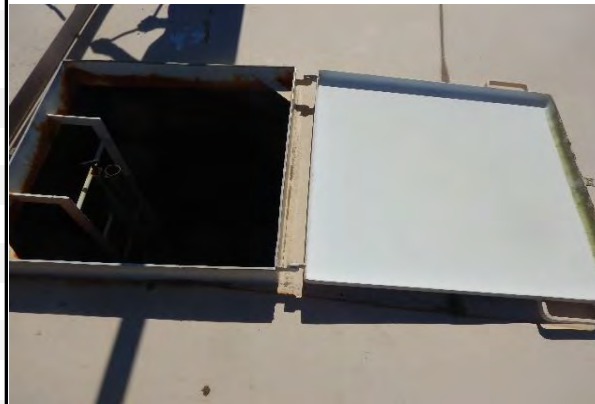
## ACCESS HATCH

**Conclusion/Discrepancies** Corrosion on the interior of the riser. Lid and hardware in good condition. Gasket present locked and secured.

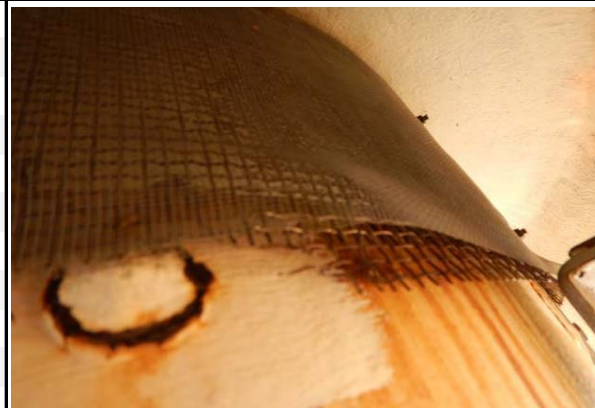
## VENTS

**Conclusion/Discrepancies** Screen and riser have corrosion present. The edges of the screen are not sealed.. No holes or tears in the screen itself, overall in good condition just needs to be sealed on the edges.

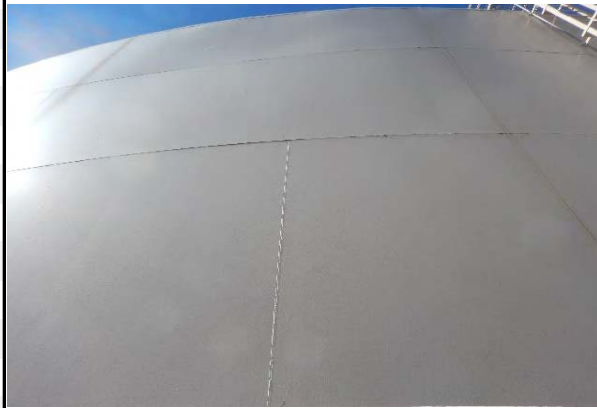
## EXTERIOR SHELL

Chime	Good
2nd Weld Ring	Good
3rd Weld Ring	Good
4th Weld Ring	Good
5th Weld Ring	Good
Ring(s) 5 in all	Good
Wall to Roof Seam	Good

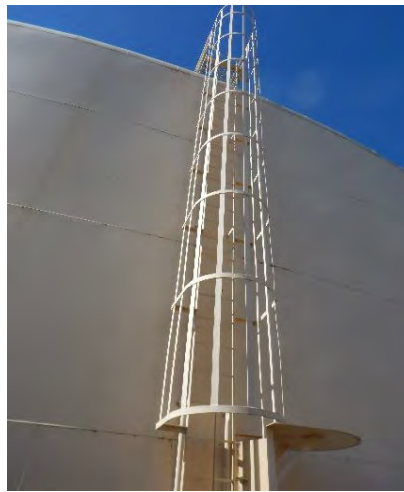
Conclusion/Discrepancies      Ladder, cage and  
 braces are all in good condition locked and secured

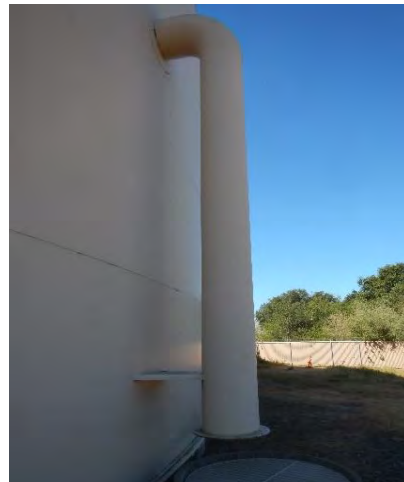
## OVERFLOW STRUCTURE

Attachments      Pipe  
 Foundation      Good  
 Conclusion/Discrepancies      Pipe and screen are  
 in good condition

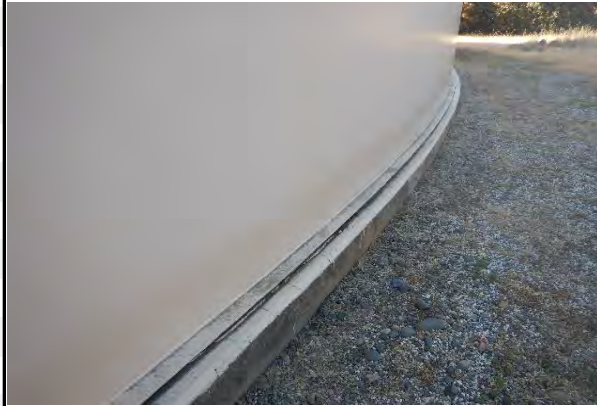
## FOUNDATION

<b>Concrete Slab/Ring</b>				
Satisfactory	Y	<input checked="" type="checkbox"/>	N	<input type="checkbox"/>
Cracking	Y	<input type="checkbox"/>	N	<input checked="" type="checkbox"/>
Spalling	Y	<input type="checkbox"/>	N	<input checked="" type="checkbox"/>
Exposed Aggregate	Y	<input type="checkbox"/>	N	<input checked="" type="checkbox"/>
Erosion Undermining	Y	<input type="checkbox"/>	N	<input checked="" type="checkbox"/>
Seismic Restraints	None			
Corrosion	Y	<input type="checkbox"/>	N	<input type="checkbox"/>
Tight	Y	<input type="checkbox"/>	N	<input type="checkbox"/>
Conclusion/Discrepancies	Support ring is in good condition. No undermining or erosion noted

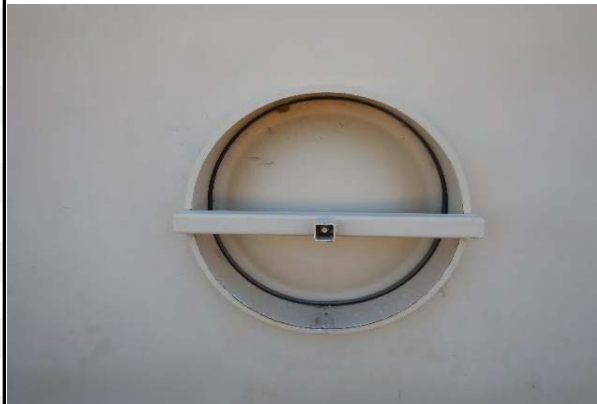
## MANWAY ENTRIES

<b>Coating</b>					
Satisfactory	Y	<input checked="" type="checkbox"/>	N	<input type="checkbox"/>	
Oxidized	Y	<input checked="" type="checkbox"/>	N	<input type="checkbox"/>	
Pitting	Y	<input type="checkbox"/>	N	<input checked="" type="checkbox"/>	
Delamination	Y	<input type="checkbox"/>	N	<input checked="" type="checkbox"/>	
Corrosion	<2%	Y	<input checked="" type="checkbox"/>	N	<input type="checkbox"/>
Welds/Joints	Good				
Conclusion/Discrepancies	Minor corrosion on the edges of the extensions. Gaskets are holding up well with no leaks. All hardware is in place.

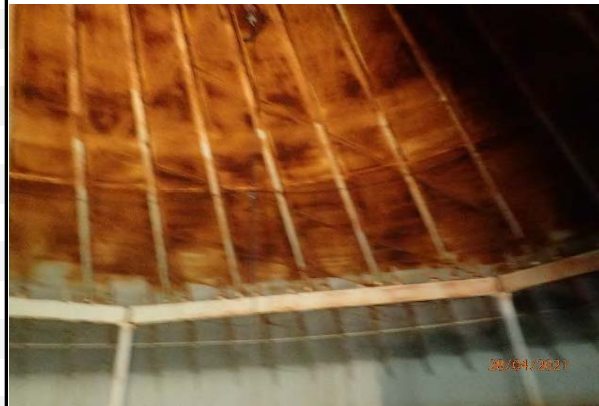
## INTERIOR ROOF

Vent Penetration					
Fair-poor					
Roof Hatch					
Fair-poor

**Conclusion/Discrepancies:** Coating on the edges of the trusses has failed and corrosion has damaged the edges of the trusses. Corrosion also noted along the seams

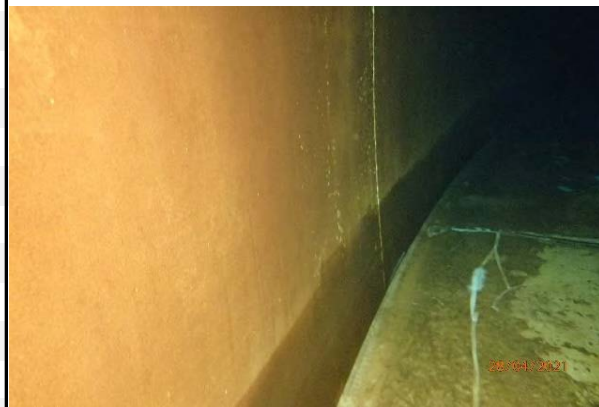
Coating					
Satisfactory	Y	<input checked="" type="checkbox"/>	N	<input type="checkbox"/>	
Blistering	Y	<input type="checkbox"/>	N	<input checked="" type="checkbox"/>	
Cracking	Y	<input type="checkbox"/>	N	<input checked="" type="checkbox"/>	
Peeling	Y	<input type="checkbox"/>	N	<input checked="" type="checkbox"/>	
Holidays	Y	<input type="checkbox"/>	N	<input checked="" type="checkbox"/>	
Pitting	Y	<input type="checkbox"/>	N	<input checked="" type="checkbox"/>	
Corrosion	%	Y	<input type="checkbox"/>	N	<input type="checkbox"/>
Seams/Welds	Good				
Rings					
Chime	Good				
2nd Weld Ring	Good				
3rd Weld Ring	Good				
4th Weld Ring	Good				
5th Weld Ring	Good				
Ring(s)	5 in all	Good			
Wall to Roof Seam	Good

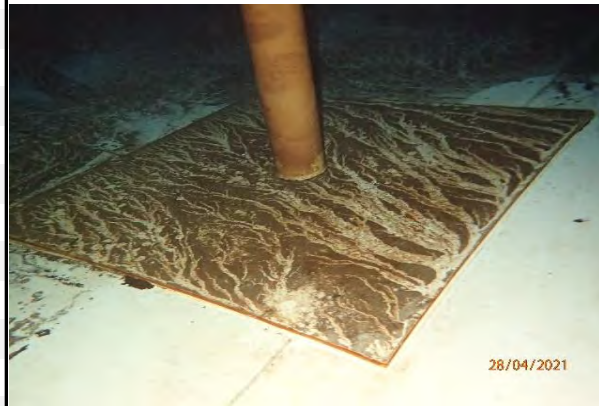
Coating				
Satisfactory	Y	<input checked="" type="checkbox"/>	N	<input type="checkbox"/>
Blistering	Y	<input type="checkbox"/>	N	<input checked="" type="checkbox"/>
Cracking	Y	<input type="checkbox"/>	N	<input checked="" type="checkbox"/>
Peeling	Y	<input type="checkbox"/>	N	<input checked="" type="checkbox"/>
Holidays	Y	<input checked="" type="checkbox"/>	N	<input type="checkbox"/>
Pitting	Y	<input type="checkbox"/>	N	<input checked="" type="checkbox"/>
Corrosion	<2%	Y	<input checked="" type="checkbox"/>	N
Seams/Welds	Good			
Floor/Base Plates	Good			
Construction	Coated Steel			
Conclusion/Discrepancies:	A few minor spots of corrosion noted on the stems. Overall in good condition

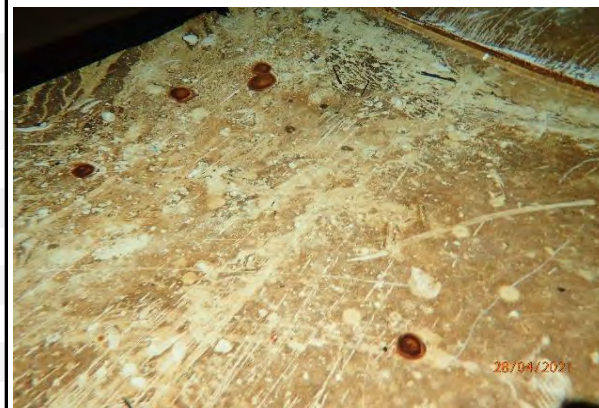
## FLOOR

Coating				
Satisfactory	Y	<input checked="" type="checkbox"/>	N	<input type="checkbox"/>
Blistering	Y	<input type="checkbox"/>	N	<input checked="" type="checkbox"/>
Cracking	Y	<input type="checkbox"/>	N	<input checked="" type="checkbox"/>
Peeling	Y	<input type="checkbox"/>	N	<input checked="" type="checkbox"/>
Holidays	Y	<input checked="" type="checkbox"/>	N	<input type="checkbox"/>
Pitting	Y	<input type="checkbox"/>	N	<input checked="" type="checkbox"/>
Corrosion	<2%	Y	<input checked="" type="checkbox"/>	N
Seams/Welds	Good			
Conclusion/Discrepancies:	several small rust spots noted sporadically over the floor. Weld seams are in good condition with no noted concerns.			
Sediment Depth	Less than a 1/16 sporadically over the floor

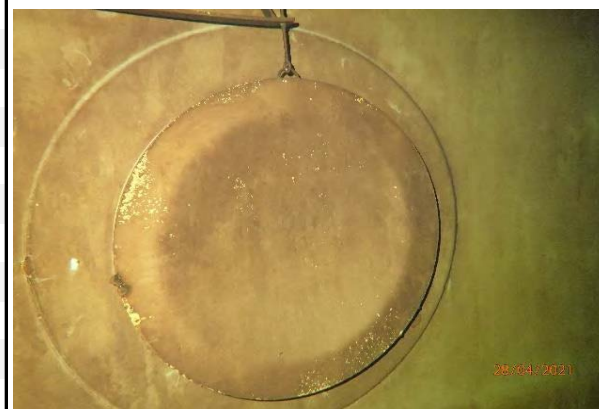
## MANWAY ENTRIES

Coating				
Satisfactory	Y	<input checked="" type="checkbox"/>	N	<input type="checkbox"/>
Blistering	Y	<input type="checkbox"/>	N	<input checked="" type="checkbox"/>
Cracking	Y	<input type="checkbox"/>	N	<input checked="" type="checkbox"/>
Peeling	Y	<input type="checkbox"/>	N	<input checked="" type="checkbox"/>
Holidays	Y	<input type="checkbox"/>	N	<input checked="" type="checkbox"/>
Pitting	Y	<input type="checkbox"/>	N	<input checked="" type="checkbox"/>
Corrosion	<2%	Y	<input checked="" type="checkbox"/>	N
Seams/Welds	Good			
Conclusion/Discrepancies:	Minor corrosion noted on the outer edges of the doors. Seams and welds are in good condition			
No leaks gasket are holding up well.

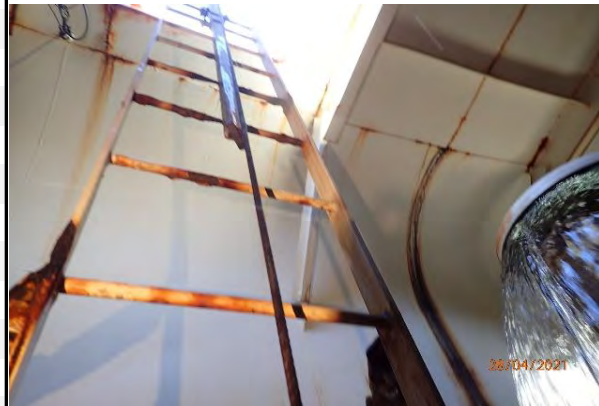
## LADDER

Construction	Coated steel			
Satisfactory	Y	<input checked="" type="checkbox"/>	N	<input type="checkbox"/>
Coating				
Satisfactory	Y	<input checked="" type="checkbox"/>	N	<input type="checkbox"/>
Blistering	Y	<input type="checkbox"/>	N	<input checked="" type="checkbox"/>
Cracking	Y	<input type="checkbox"/>	N	<input checked="" type="checkbox"/>
Peeling	Y	<input type="checkbox"/>	N	<input checked="" type="checkbox"/>
Holidays	Y	<input type="checkbox"/>	N	<input checked="" type="checkbox"/>
Pitting	Y	<input checked="" type="checkbox"/>	N	<input type="checkbox"/>
Corrosion	2%	Y	<input checked="" type="checkbox"/>	N
Seams/Welds	Good			
Safety Cage/Climb	Y	<input checked="" type="checkbox"/>	N	<input type="checkbox"/>

**Conclusion/Discrepancies:** Two rungs above the high water line have integrity loss, caution when using. Minor corrosion on the braces above water line. Overall in good-fair condition.

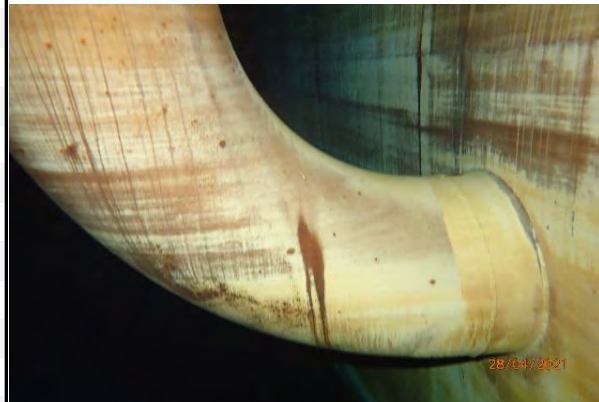
Location	9:00			
Coating				
Satisfactory	Fair	<input checked="" type="checkbox"/>	N	<input type="checkbox"/>
Blistering	Y	<input type="checkbox"/>	N	<input checked="" type="checkbox"/>
Cracking	Y	<input type="checkbox"/>	N	<input checked="" type="checkbox"/>
Peeling	Y	<input type="checkbox"/>	N	<input checked="" type="checkbox"/>
Holidays	Y	<input type="checkbox"/>	N	<input checked="" type="checkbox"/>
Pitting	Y	<input type="checkbox"/>	N	<input checked="" type="checkbox"/>
Corrosion	5%	Y	<input checked="" type="checkbox"/>	N
Seams/Welds	Good

**Conclusion/Discrepancies:** Minor spots of rust on the pipe and support brace. No pitting noted.

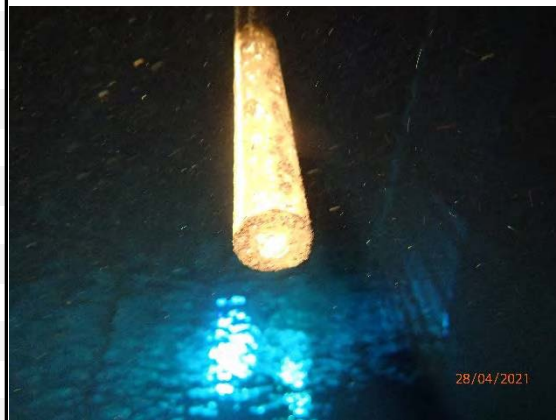
Satisfactory	Y	<input checked="" type="checkbox"/>	N	<input type="checkbox"/>
Life Left	50%			
Hardware	Y	<input checked="" type="checkbox"/>	N	<input type="checkbox"/>
Roof plates	Y	<input checked="" type="checkbox"/>	N	<input type="checkbox"/>
Missing Anodes	Y	<input type="checkbox"/>	N	<input checked="" type="checkbox"/>

**Conclusion/Discrepancies:** All anodes are in place properly suspended with all hardware in place.

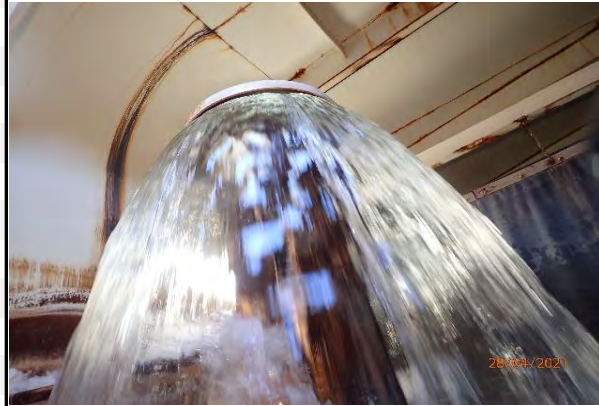
Satisfactory	Y	<input checked="" type="checkbox"/>	N	<input type="checkbox"/>	
Blistering	Y	<input type="checkbox"/>	N	<input checked="" type="checkbox"/>	
Cracking	Y	<input type="checkbox"/>	N	<input checked="" type="checkbox"/>	
Peeling	Y	<input type="checkbox"/>	N	<input checked="" type="checkbox"/>	
Holidays	Y	<input type="checkbox"/>	N	<input checked="" type="checkbox"/>	
Pitting	Y	<input type="checkbox"/>	N	<input checked="" type="checkbox"/>	
Corrosion	%	Y	<input type="checkbox"/>	N	<input checked="" type="checkbox"/>
Seams/Welds	Good

**Conclusion/Discrepancies:** Pipe and braces are in good condition. Slight discoloration but in good condition with no corrosion.

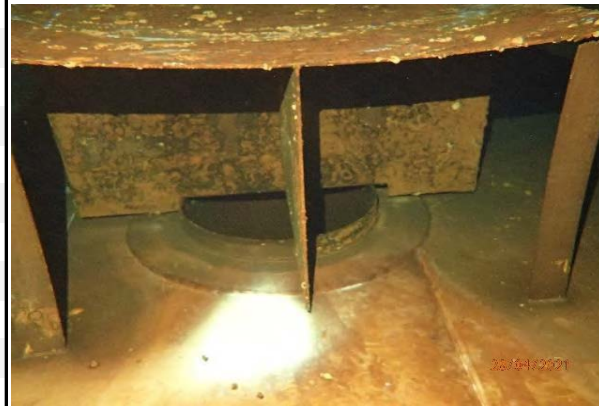
Satisfactory	Fair	<input checked="" type="checkbox"/>	N	<input type="checkbox"/>	
Blistering	Y	<input type="checkbox"/>	N	<input checked="" type="checkbox"/>	
Cracking	Y	<input type="checkbox"/>	N	<input checked="" type="checkbox"/>	
Peeling	Y	<input type="checkbox"/>	N	<input checked="" type="checkbox"/>	
Holidays	Y	<input type="checkbox"/>	N	<input checked="" type="checkbox"/>	
Pitting	Y	<input checked="" type="checkbox"/>	N	<input type="checkbox"/>	
Corrosion	5%	Y	<input checked="" type="checkbox"/>	N	<input type="checkbox"/>
Seams/Welds	Good

**Conclusion/Discrepancies:** A few rust nodules with minor pitting on the antivortex plate, pipe is in good condition, clear and unobstructed.

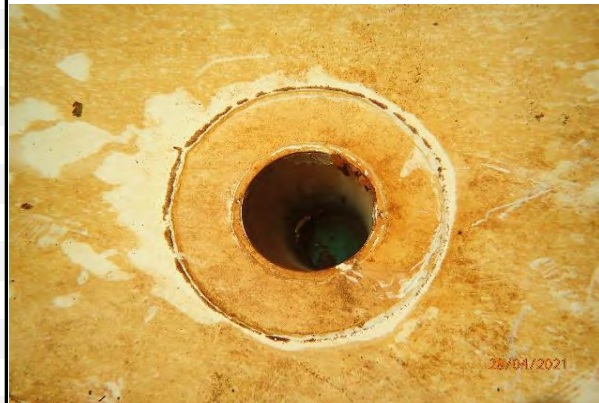
Satisfactory	Y	<input checked="" type="checkbox"/>	N	<input type="checkbox"/>	
Blistering	Y	<input type="checkbox"/>	N	<input checked="" type="checkbox"/>	
Cracking	Y	<input type="checkbox"/>	N	<input checked="" type="checkbox"/>	
Peeling	Y	<input type="checkbox"/>	N	<input checked="" type="checkbox"/>	
Holidays	Y	<input type="checkbox"/>	N	<input checked="" type="checkbox"/>	
Pitting	Y	<input type="checkbox"/>	N	<input checked="" type="checkbox"/>	
Corrosion	2%	Y	<input checked="" type="checkbox"/>	N	<input type="checkbox"/>
Seams/Welds	Fair

**Conclusion/Discrepancies:** minor corrosion on the interior weld seam.

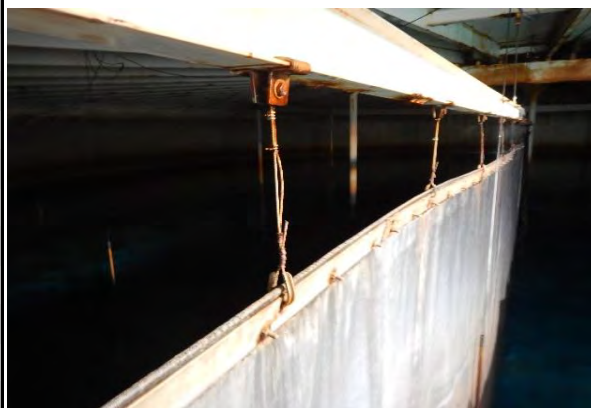
Seams/Welds Good

Conclusion/Discrepancies: corrosion on hanging hardware and the truss.

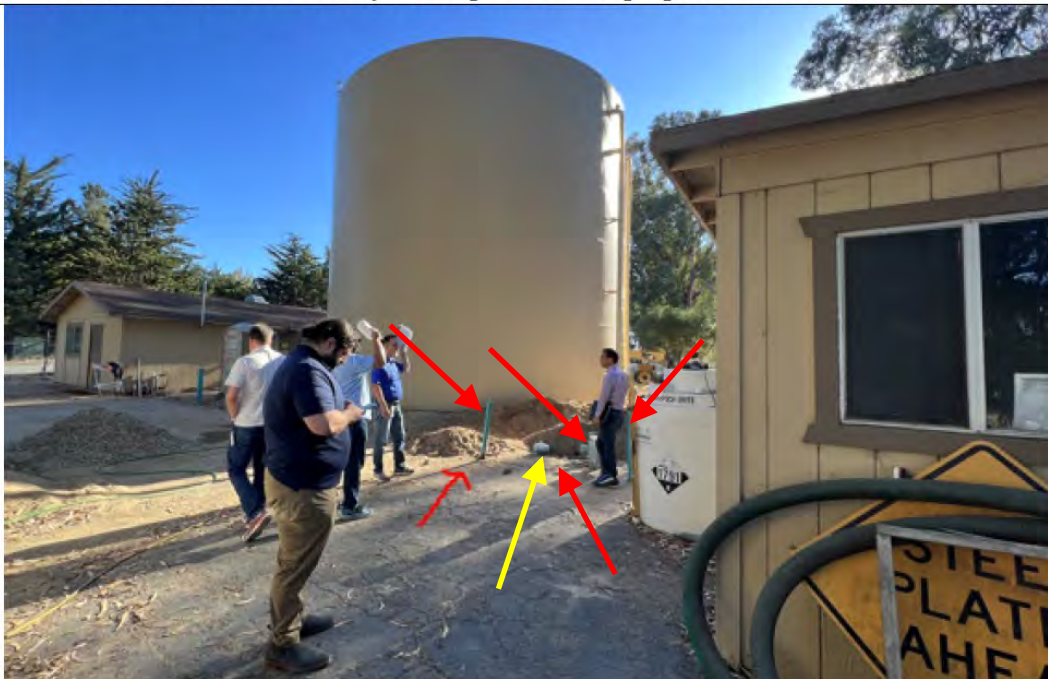
Picture-2. Cal Advocates field trip to El Campo plant site on November 1, 2023

During Cal Advocate field trip to the El Campo plant on November 1, 2023, see picture -2 around the area of the blue pole. GSWC pointed out that Rural Well #1 is located around the blue pole. However, as shown in the picture, no structures around the blue pole exist.

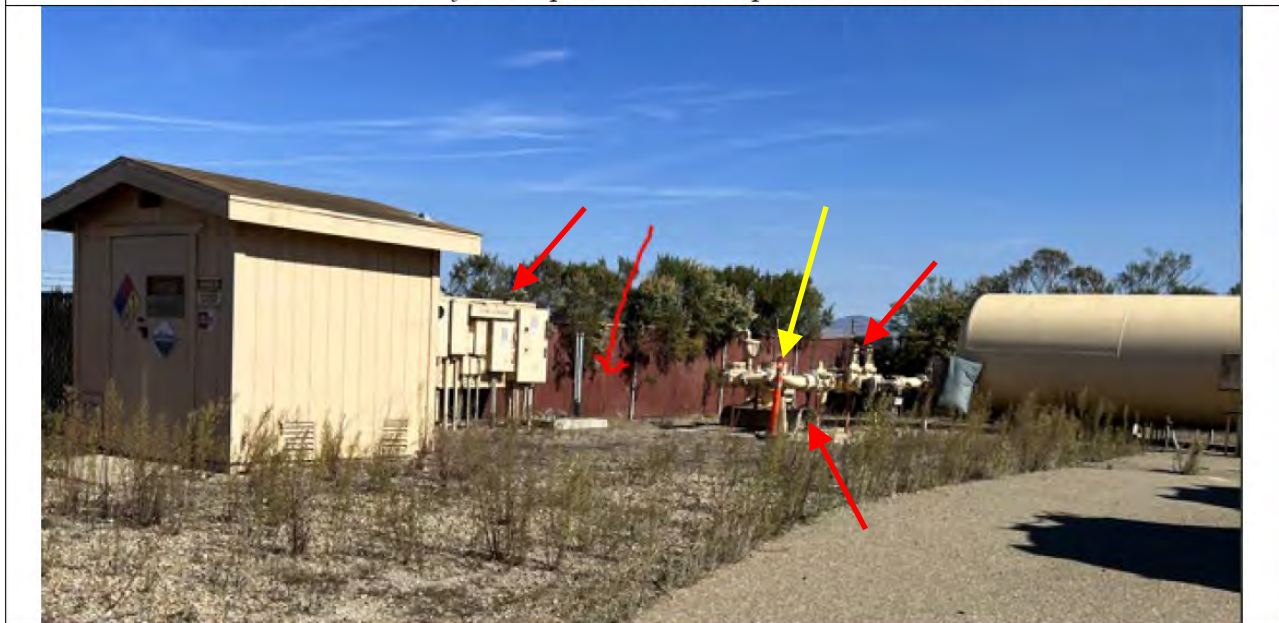
Picture-3. *Cal Advocates field trip to Willowood plant site on November 2, 2023*

During Cal Advocates' field trip to the Willowood plant on November 2, 2023, see picture - 3 with a red arrow, GSWC pointed out that Willowood Well #1 is around the red arrow area.

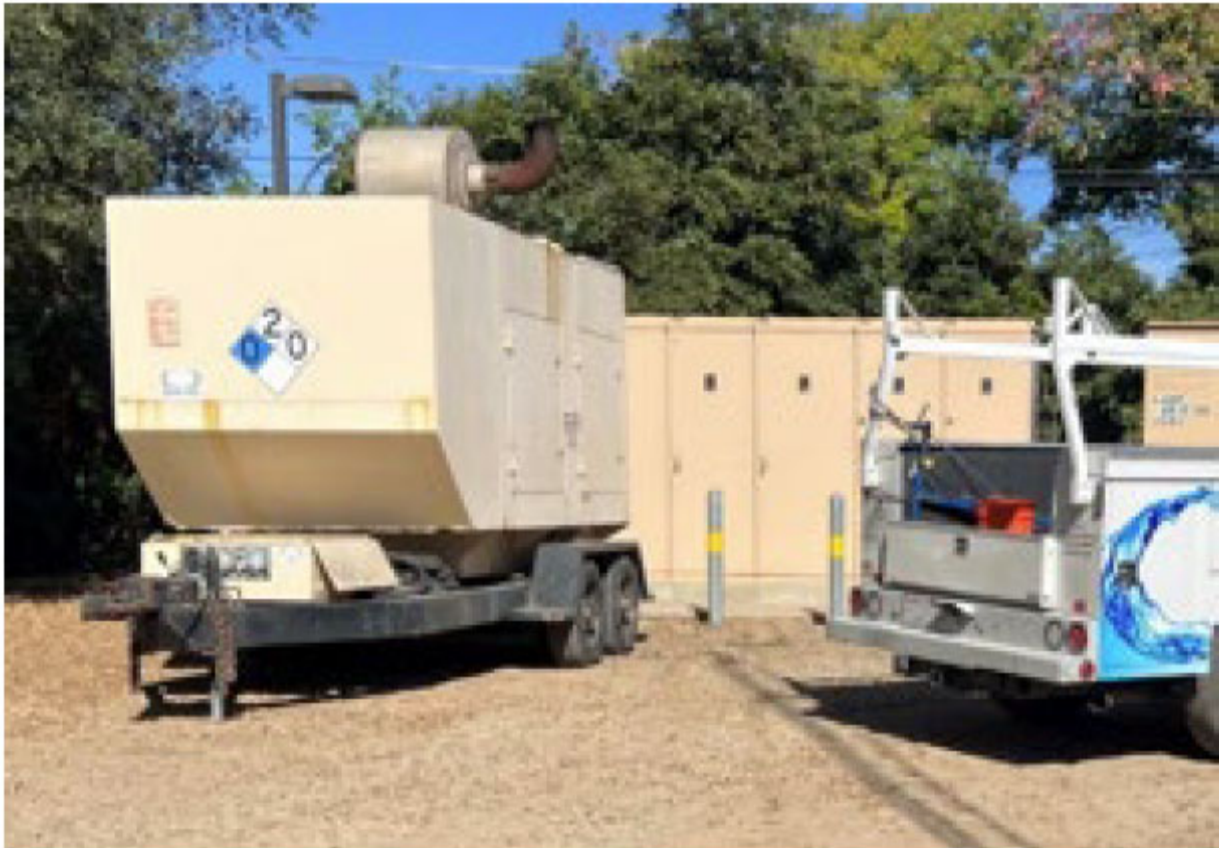
During the site visit (Nov 2, 2023) to the Lake Marie plant, GSWC stated that a power outage recently occurred, and a portable generator was brought from another GSWC plant to operate at the Lake Marie plant because the new permanent generator (CWIP project) was not yet operable.
