**PUBLIC ADVOCATES OFFICE**  
**CALIFORNIA PUBLIC UTILITIES COMMISSION**

**REPORT AND RECOMMENDATIONS**  
**ON REGION I - CAPITAL PROJECT FORECAST:**  
**(ARDEN CORDOVA, BAY POINT,**  
**CLEARLAKE, LOS OSOS,**  
**SANTA MARIA & SIMI VALLEY)**

Los Angeles, California  
February 27, 2024

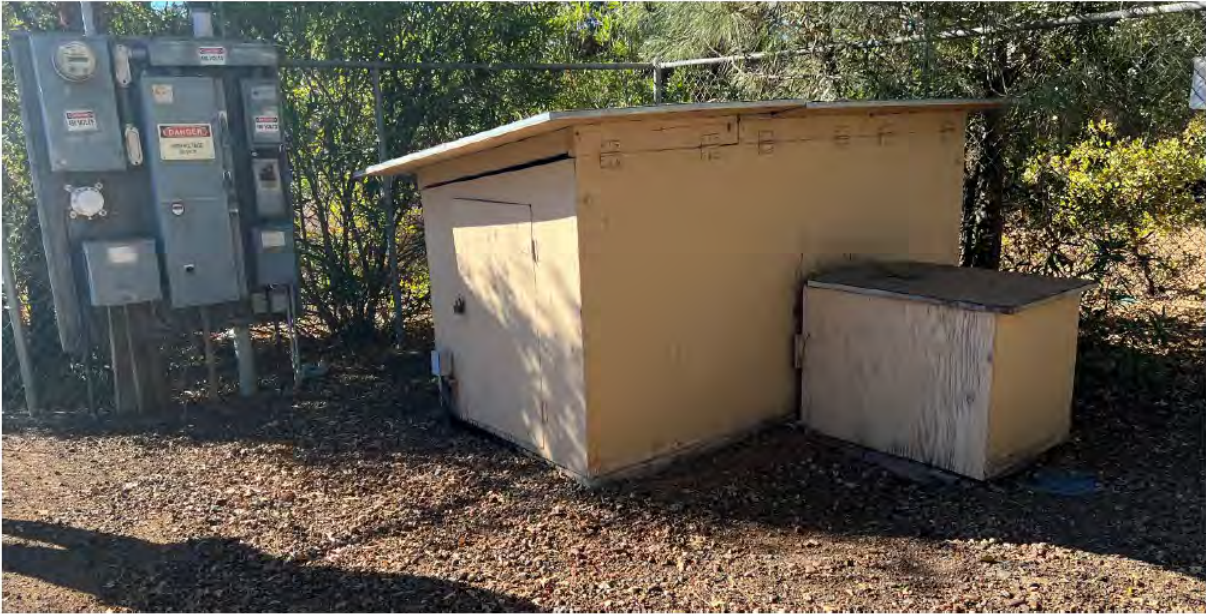
Picture-1. *Cal Advocates field trip to Manchester plant site on October 30, 2023*

See pictures 1 & 2 taken during Cal Advocates' field trip to the Manchester plant on October 30, 2023. During the site visit, GSWC did not open the roof of the wooden structure. Please explain whether the roof can be opened to allow authorized staff to operate or service the pump.

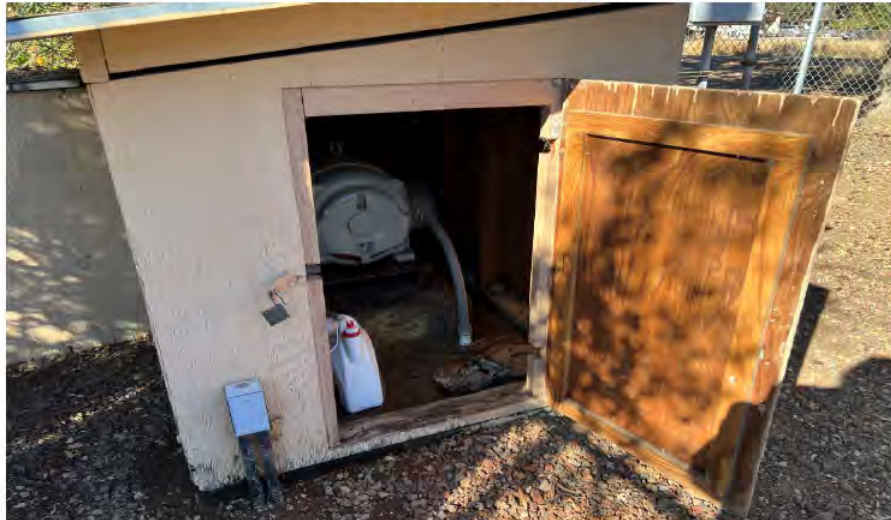
Picture-2. *Cal Advocates field trip to Manchester plant site on October 30, 2023*

The roof structure is hinged and capable of being held open for access to the pump and motor, but it is cumbersome and not ideal for maintenance as it is difficult for the operator to move around the equipment in such a small space.
